St. Francis Hospital

Building Assessment

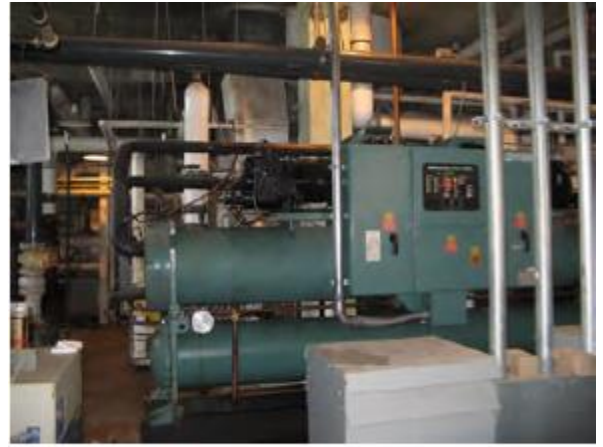
Above: York Chiller

HVAC: The majority of the existing HVAC equipment is in need of repair due to lack of use and age. There are four large rooms with a designated mechanical room function. The cost of operating the original mechanical equipment became a financial burden and the performance of the mechanical equipment is less than desirable to control the interior environment. A combination of roof top units, window units, a cooling tower, chiller, boilers, and 4-pipe fan coil units are used for heating and cooling. In 2005, a York Chiller was installed and this equipment has

potential for reuse. There is also a back-up generator and fuel tank which used to serve the Hospital located on the south side of the building.

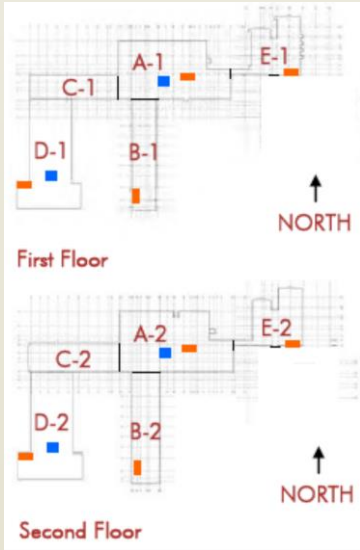
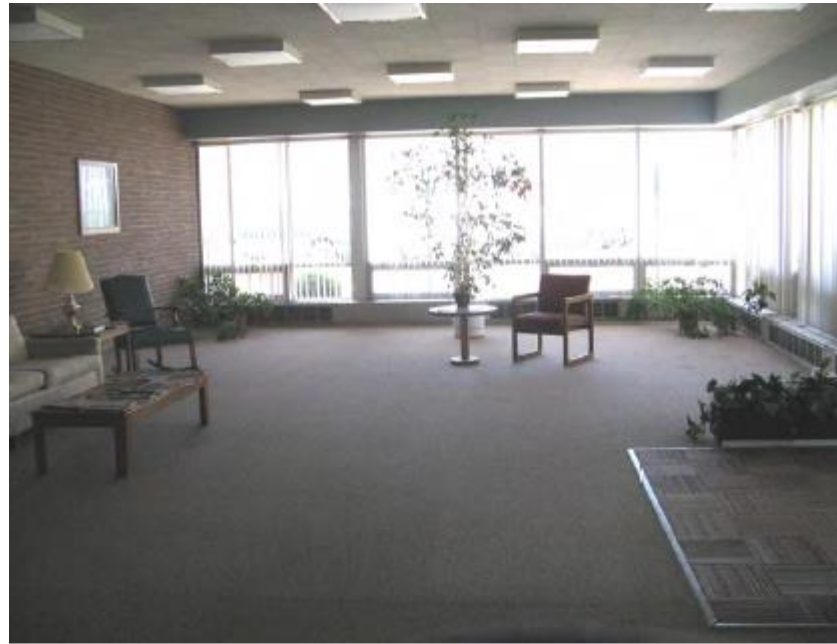
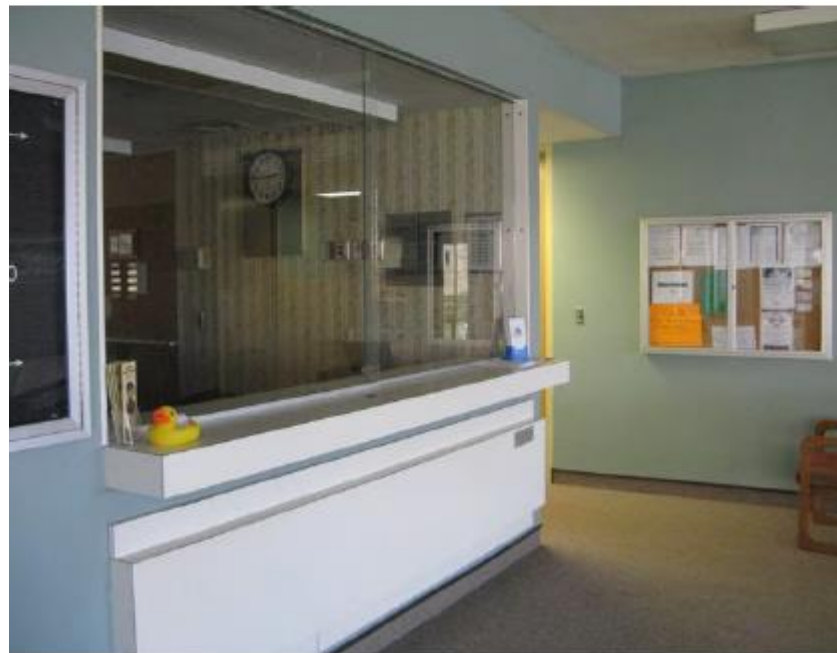
Building Unit A is the most viable area of the entire building and is in the best condition for reuse. The key features of building unit A include a large main entry lobby, reception desk, large meeting room and an operational commercial kitchen. Vertical circulation is available with a centrally located flight of stairs. There is an existing elevator that is currently inoperable. Exit doors are present on both the first and second levels to allow for egress.

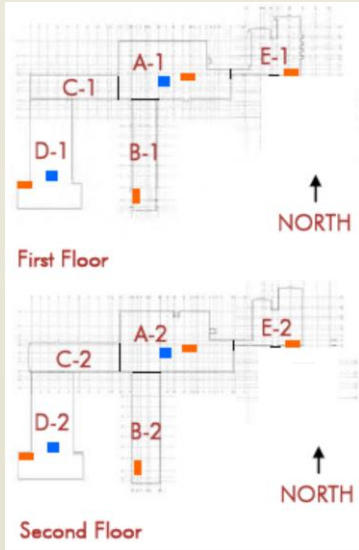
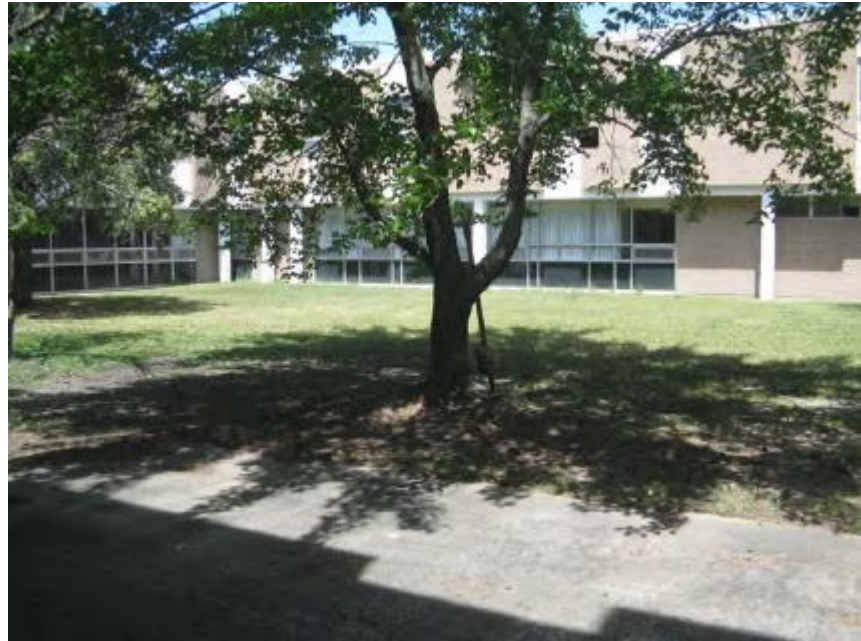
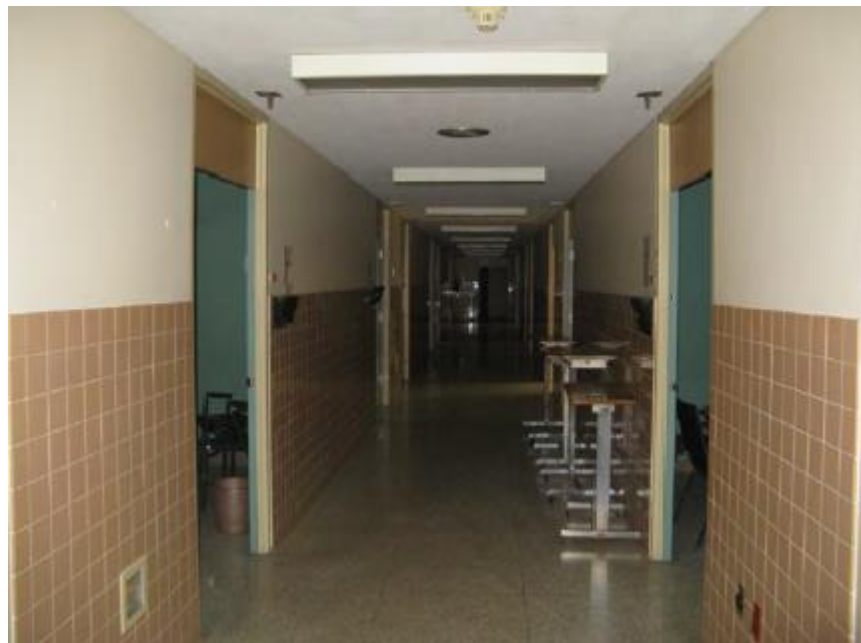
Building Unit B

The south side of B-1 contains a 2-door garage with a low ceiling height accessed from West Ira Street. There is a cafeteria to the north which serves the commercial kitchen found in A-1. Vacant patient rooms are located on either side of the connecting corridor. On B-2 there are additional patient rooms and a solarium on the south end. Without proper maintenance and basic up-keep, several of the patient rooms will require re-work prior to utilization. An egress stair exists directly outside from B-2. The other egress possibility for B-2 requires passage through A-2.

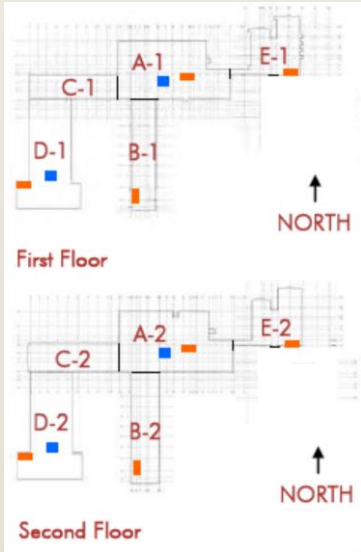
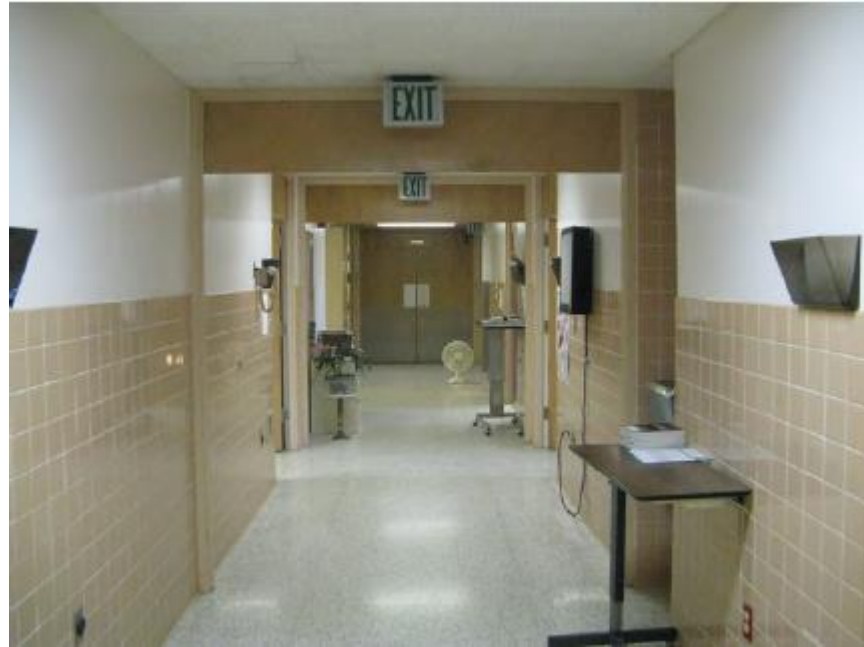
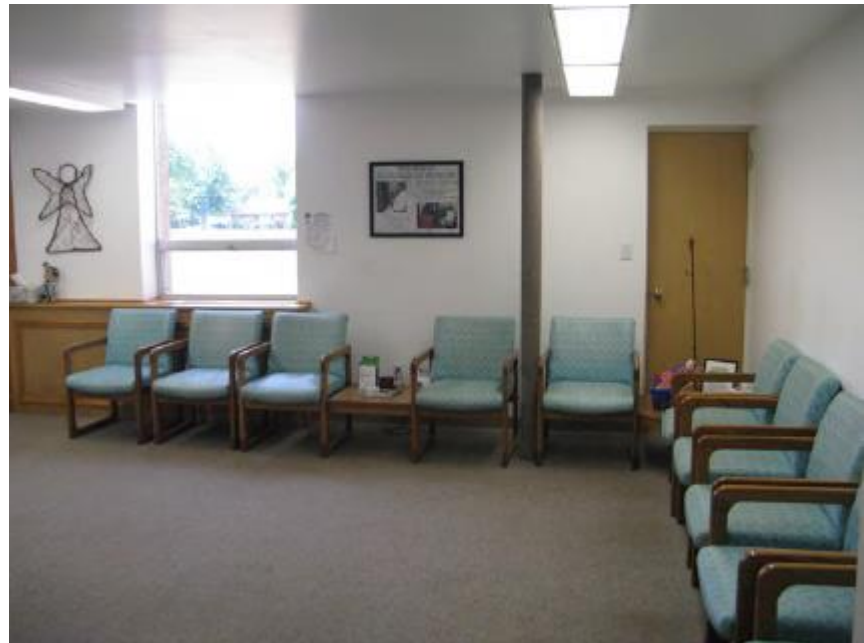
Building Unit C

Patient rooms on C-2 are the primary, current function found in building unit C. Most of C-1 is used for storage and mechanical rooms with little connection to the outside. This building does not contain a connecting flight of stairs or elevator. It may be necessary to install a new stair or elevator to meet the needs of future building functions.

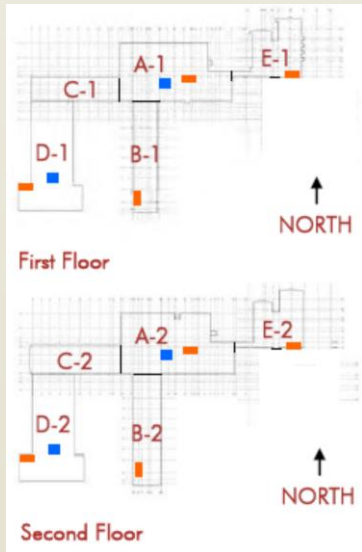
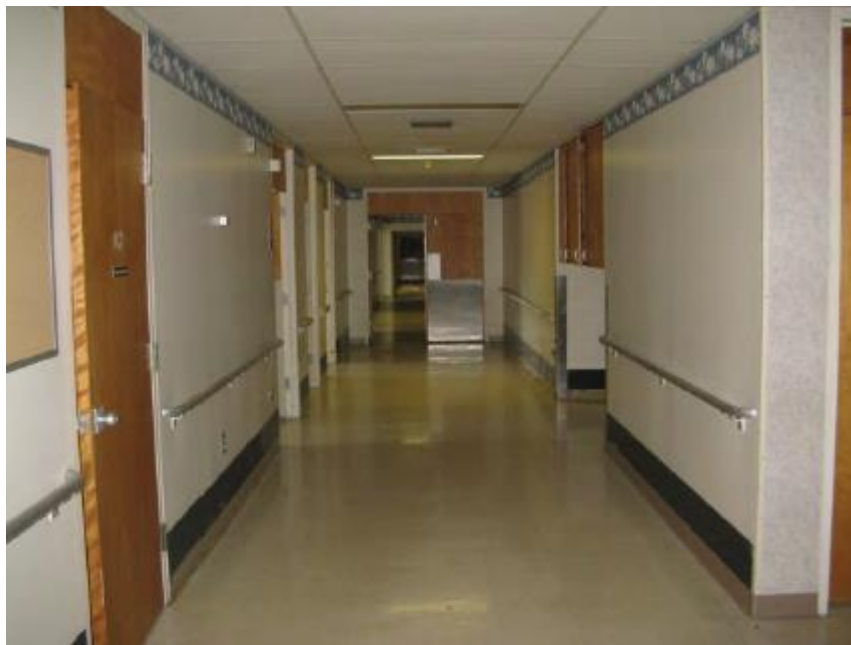
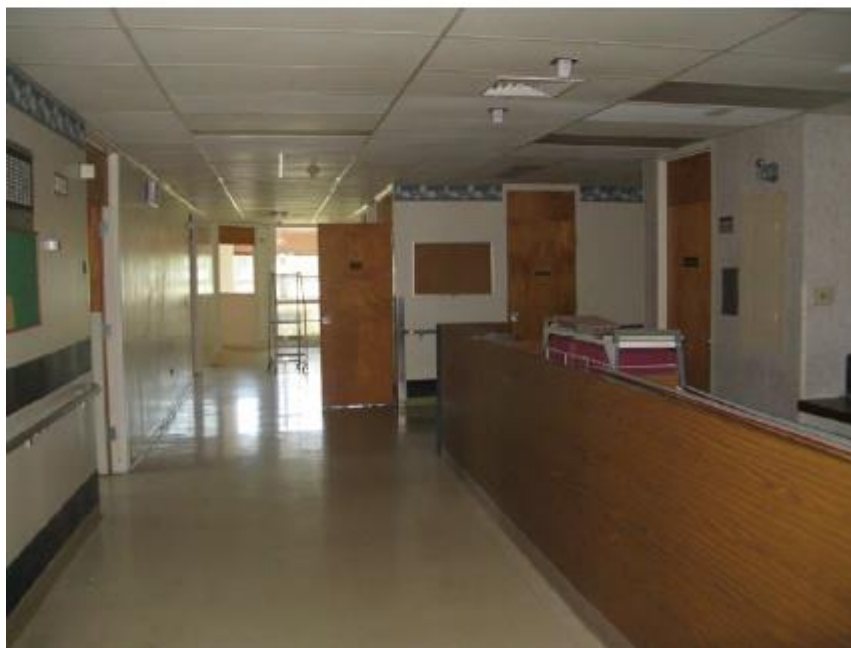
Building Unit D

The area of the building is also referred to as the Southwest Wing. It was building shortly after the rest of the building. Even though it is slightly newer, this portion of the building has slight water damage from a leaky roof. Building unit D once operated as a nursing home or assisted living facility. Bedrooms or patient rooms are located on the second floor and meeting rooms on the first floor. There is garage space on the south side of the first floor that is accessed from West Ira Street. There is an elevator and stair that connect both floors. A main entry and lobby also service building unit D from a separate parking lot to the west.

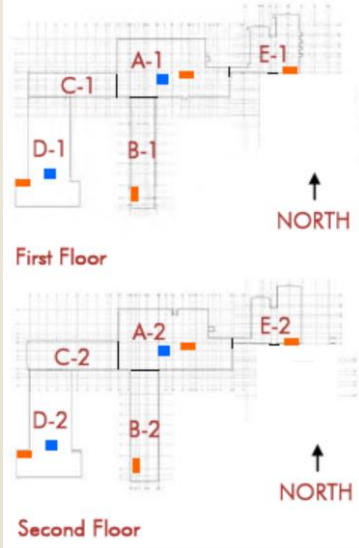
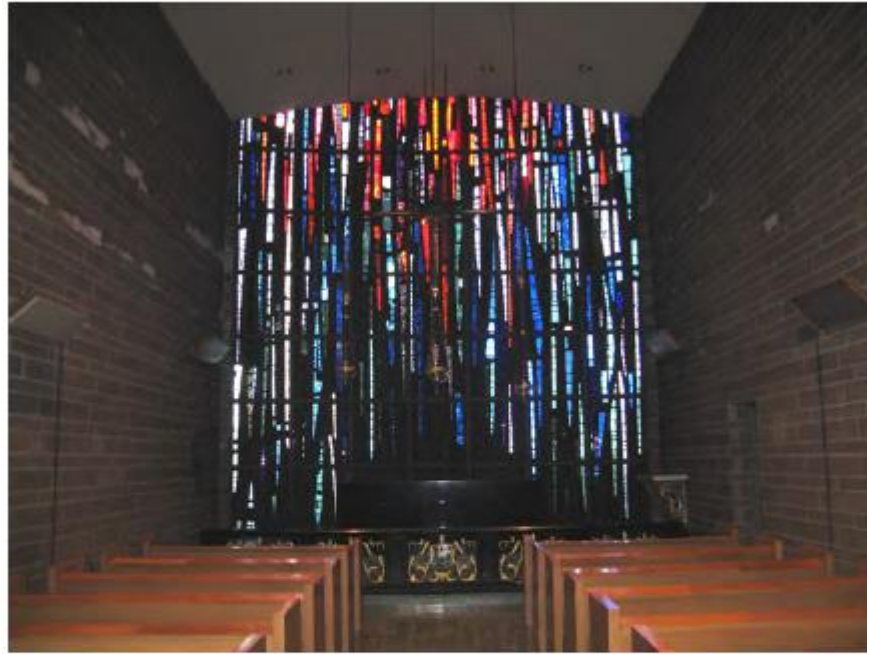
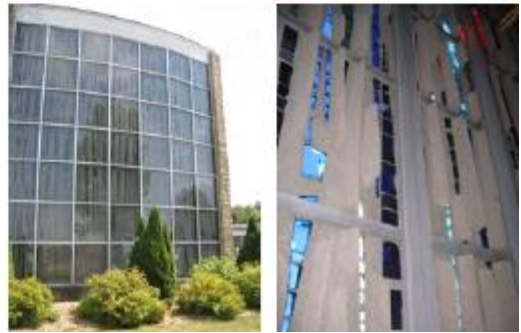
Building Unit E

Building unit E consists of the former Chapel and Priest living quarters. There is an exterior door located on E-2 at the northeast corner which gives access to an exterior patio. A flight of switch back stairs is located at the southeast corner and connects the two floor levels. This building unit connects with both A and F via corridors.
